FINDINGS and RECOMMENDATION REPORT

CITY OF GRANDVIEW – RAYTOWN ROAD

Twin 17'-2" x 11'-4" Structural Plate Arch Culverts

City of Grandview, Missouri
Raytown Road approximately 4,000 ft. north of High Grove Road
Roadway Station 52+00.00

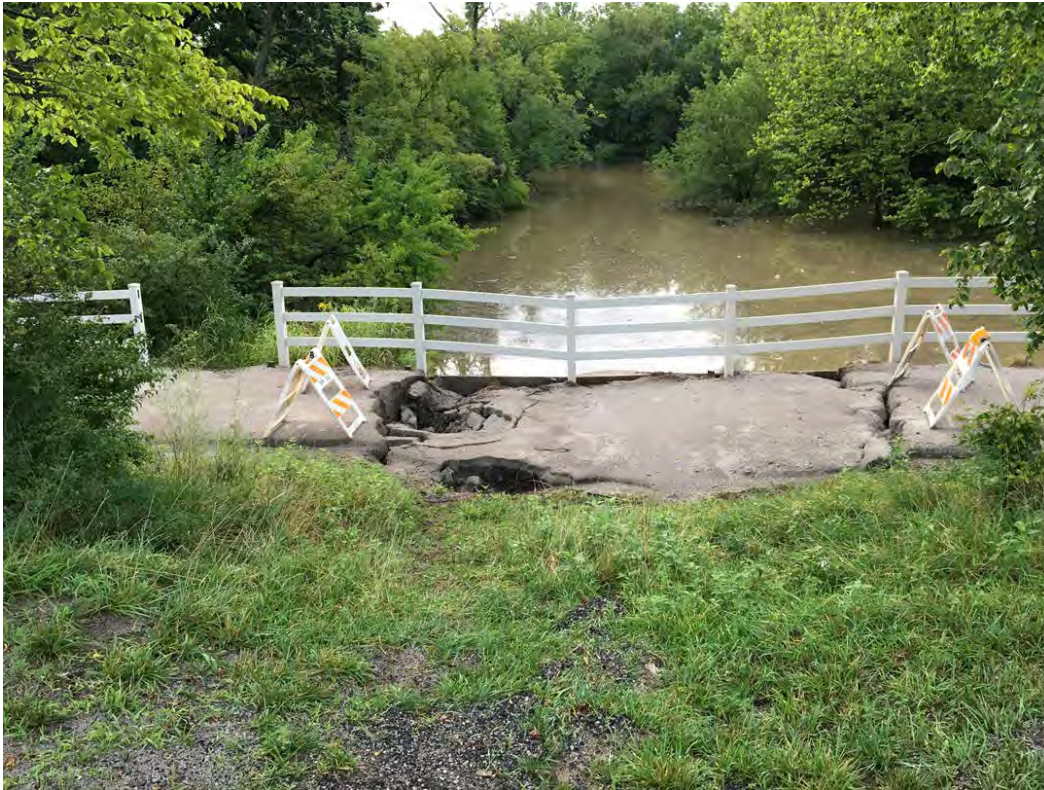
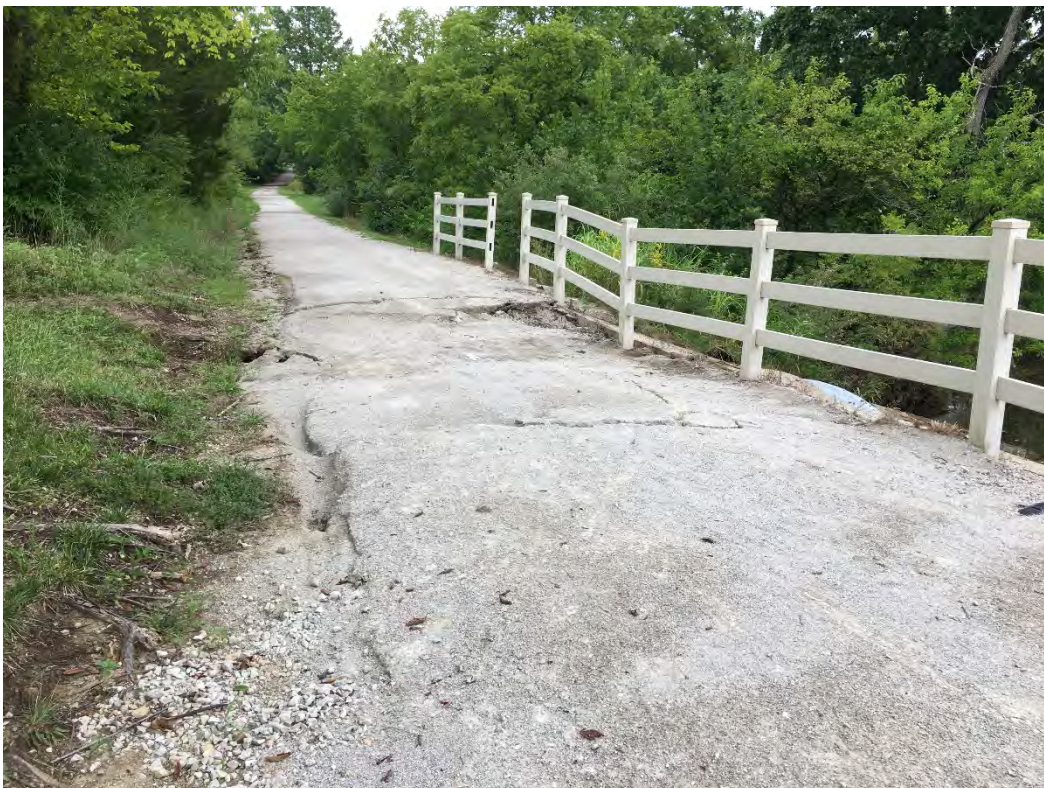
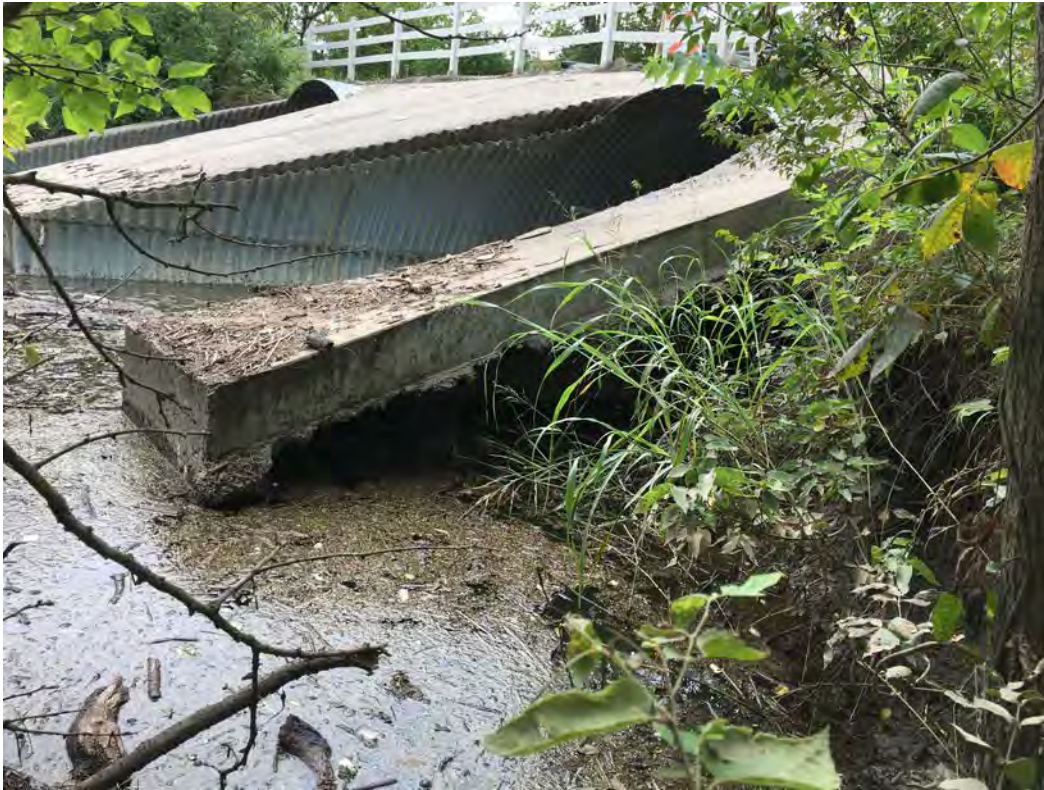
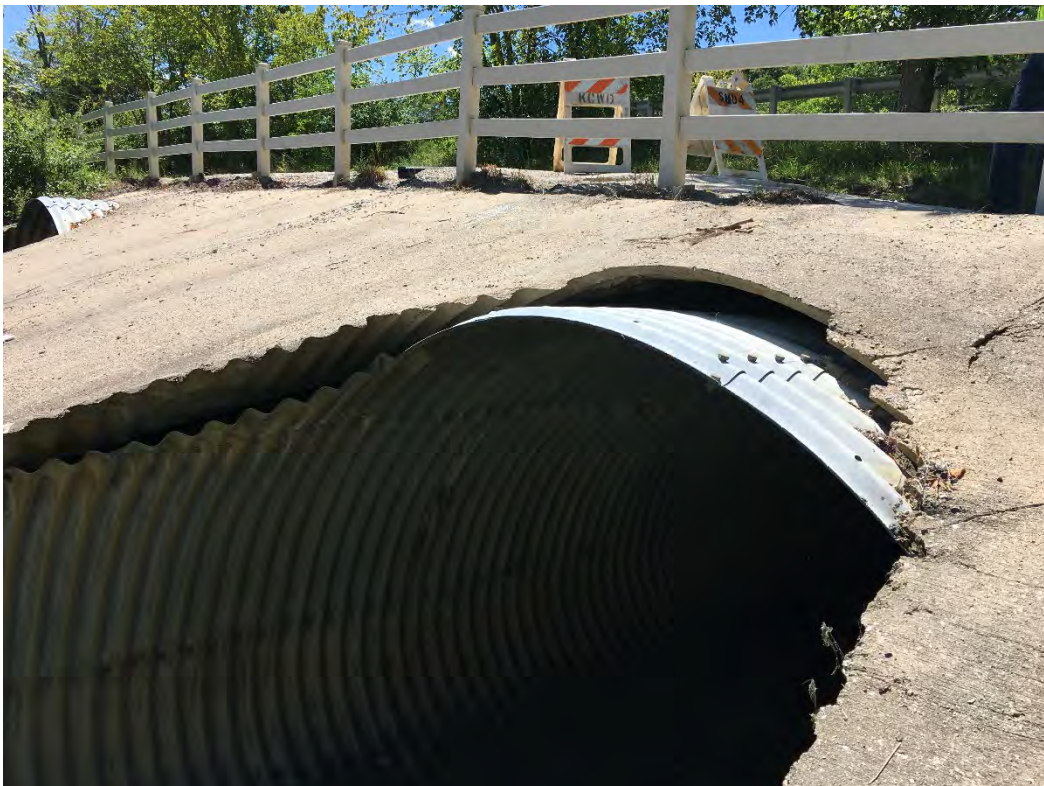
Runoff from Raytown Road has eroded and undermined roughly 30' to 40' of the trail above the culverts. After encountering the trail, the runoff then appears to run under the concrete apron cast around the downstream end of the culverts and has been washing fill material out from under the trail, the concrete apron and around the culverts. See photos 1- 4.

Photo 1 – looking east at the failed portion of the shared-use trail from Raytown Rd, 8-6-2017.

Photo 2 – looking north along the shared-use trail, 7-31-2017.

Photo 3 – looking south towards the exposed outside face at the downstream end of the north culvert.

Photo 4 – downstream end of the north culvert showing 8" gap between the concrete apron and the top of the culvert.

Has settled / separated 8" from the concrete apron.

To reopen the trail, we recommend that roughly a 50' long section over the culverts be removed down to the top of the culverts. The opening then backfilled with rock that has a predominant size in the 4" to 12" range up to a level at or slightly above the top of the concrete apron. Two layers of geotextile fabric would be placed over the rock and then the trail rebuilt over the fabric and having a thickness of 24". On the roadway (west) side of the trail a ditch would be graded to capture runoff from the roadway and drain the runoff either north and/or south away from the culverts. Refer to the sketch in Figure 2 included towards the end of this report.

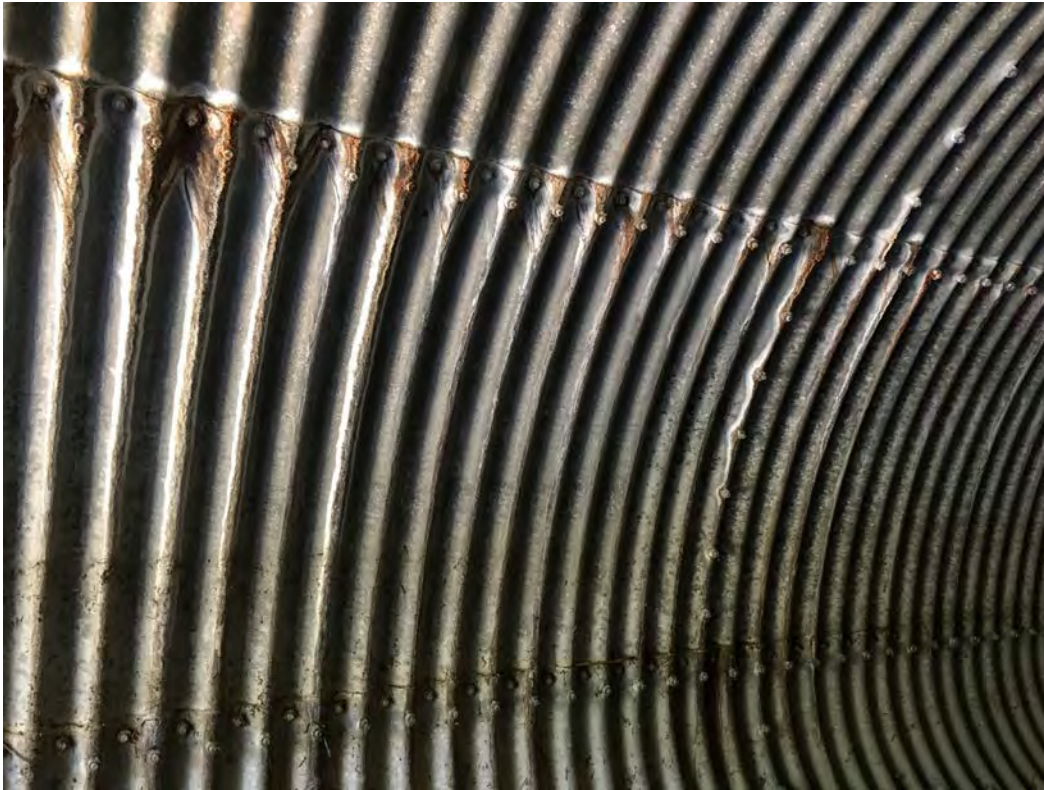
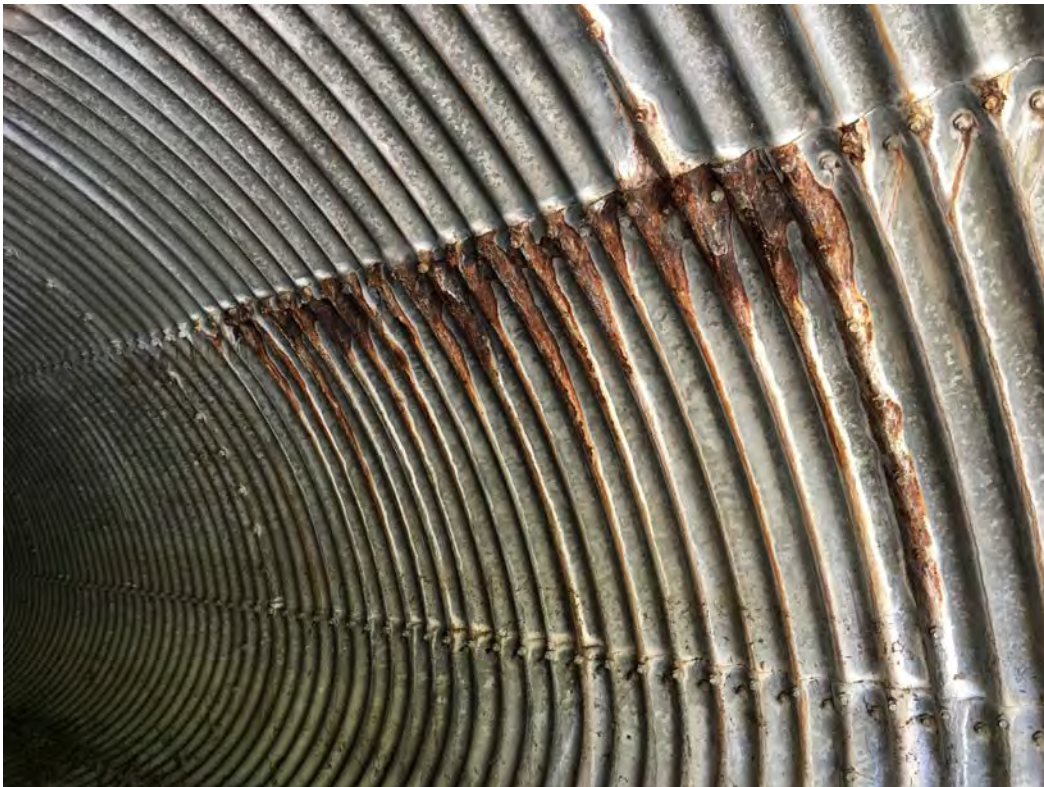
In addition, runoff from the road is seeping through the roadway embankment into the culverts near the interface with the concrete apron on both the upstream side and the downstream side. At these locations there is some deterioration of the culverts where the galvanized coating is no longer evident and the structural steel has begun rusting. See photos 5 and 6.

Photo 5 – north face of the north culvert roughly 30' from the upstream end.

Photo 6 – south face of the south culvert roughly 30' from the upstream end.

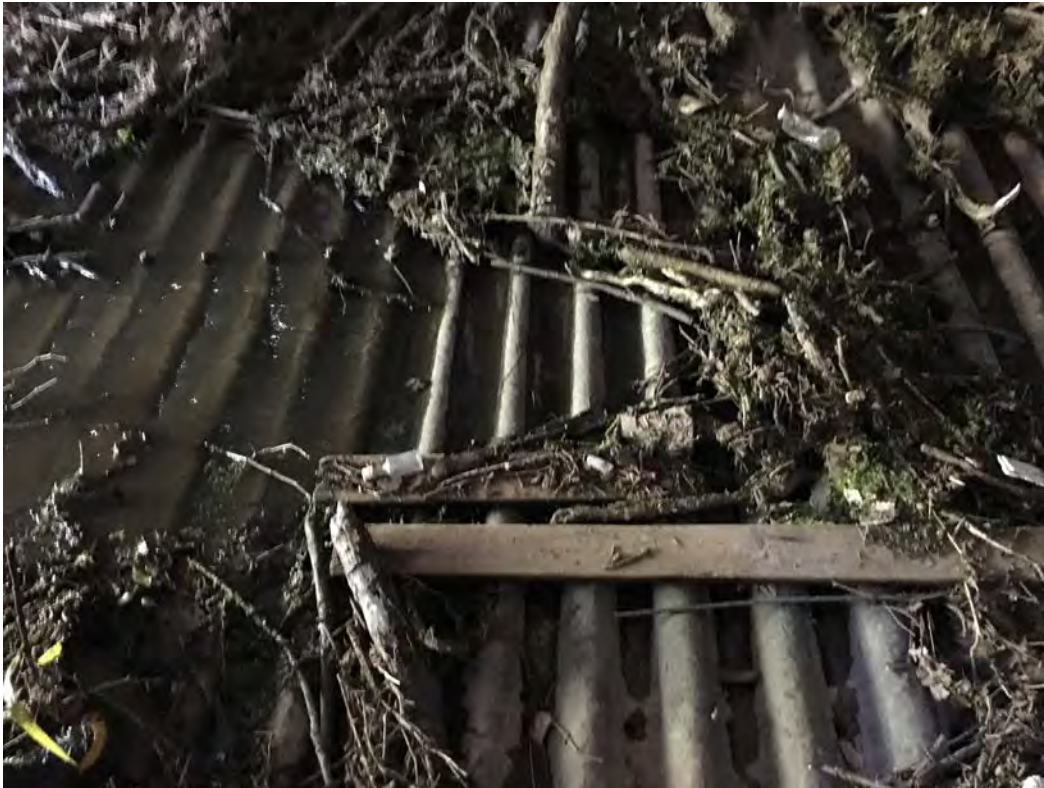
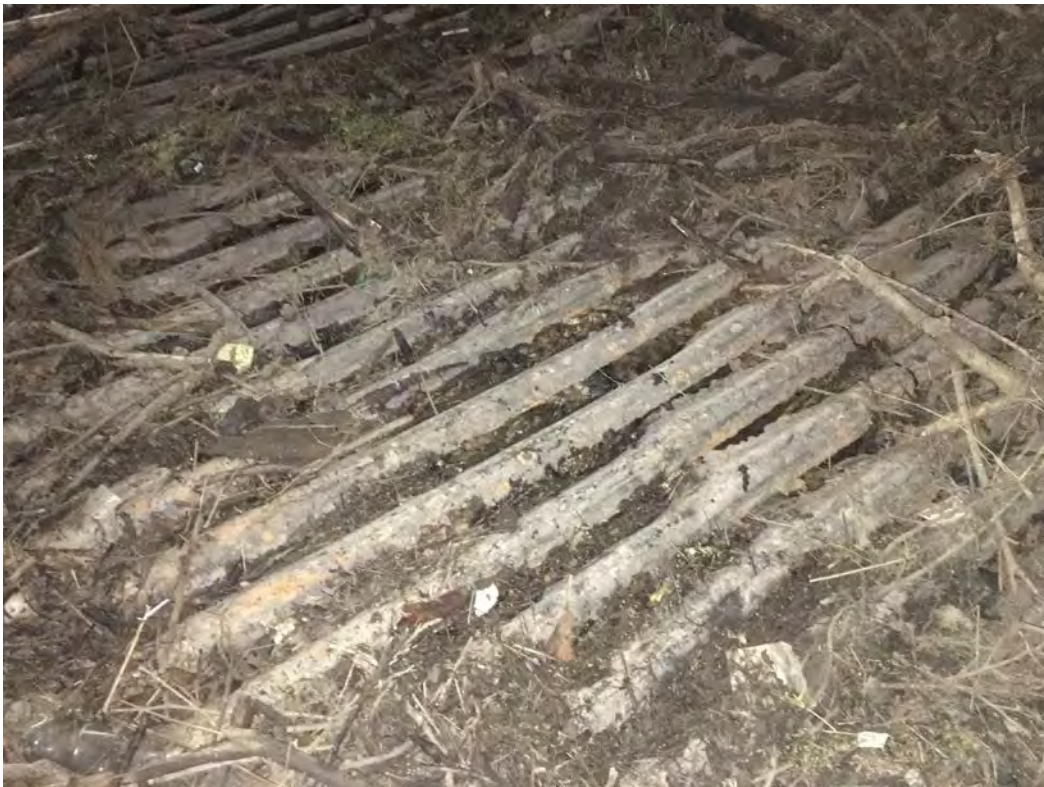
In the north culvert a large percentage of the bottom corrugations are rusted out. Holes of various sizes and lengths exist in the trough of the corrugations beginning at a distance roughly 40' from the upstream end and extending to a point roughly 110' from the upstream end. In this area water was seen running down thru the corrugations and under the culvert before reemerging back up through the bottom corrugations. Probing indicated the depth of undermining and/or depth of soft material beneath the culvert to be 6" to 12" deep. Refer to photos 7 and 8 and Figure 1.

In our opinion the north culvert has reached the end of its useful life due to settlement, undermining and deterioration. At this time there is no apparent buckling or failure of the culvert but its condition should be monitored and checked after each significant rainfall event.

Photo 7 – water running thru the deteriorated corrugations of the north culvert at roughly 40' from the upstream end.

Photo 8 – general condition of the bottom corrugations in the north culvert.

It is recommended that both culverts be replaced with twin single span 105' long bridges. The proposed bridge length would place the abutments behind 2:1 front slopes and at or behind the top of the channel banks to avoid on-going scour issues, debris problems and maintenance costs. This would also improve the channel hydraulics, its alignment and allow Raytown Road to remain open to traffic during construction.

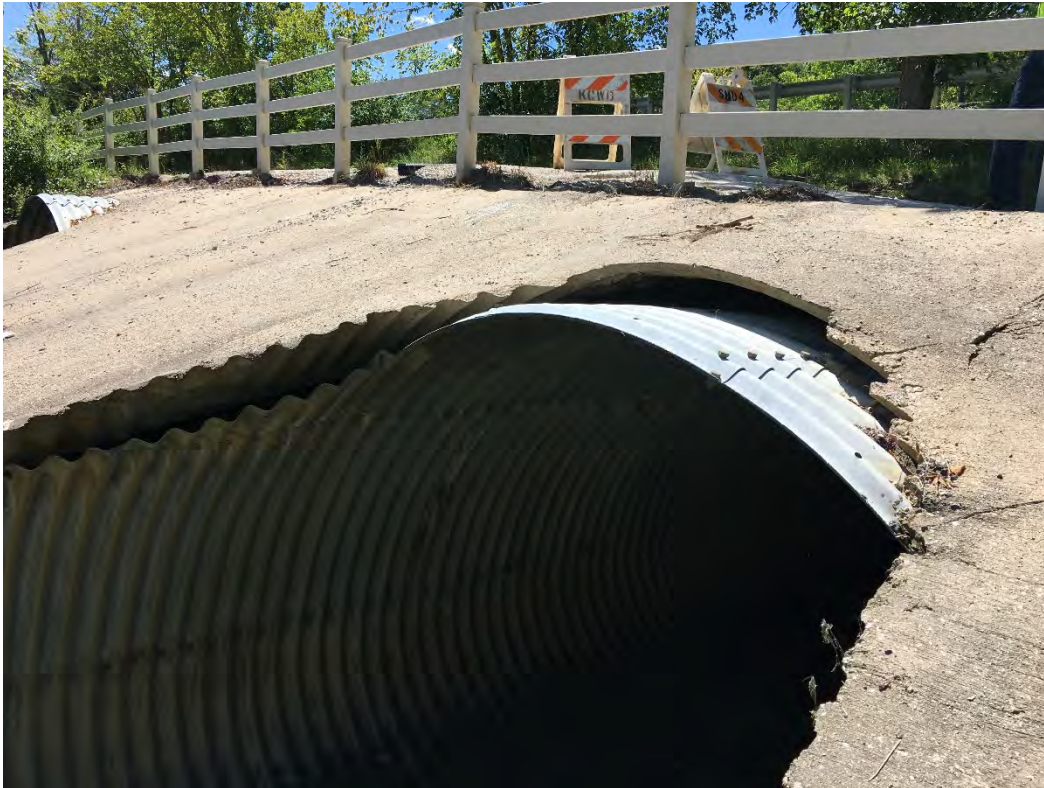
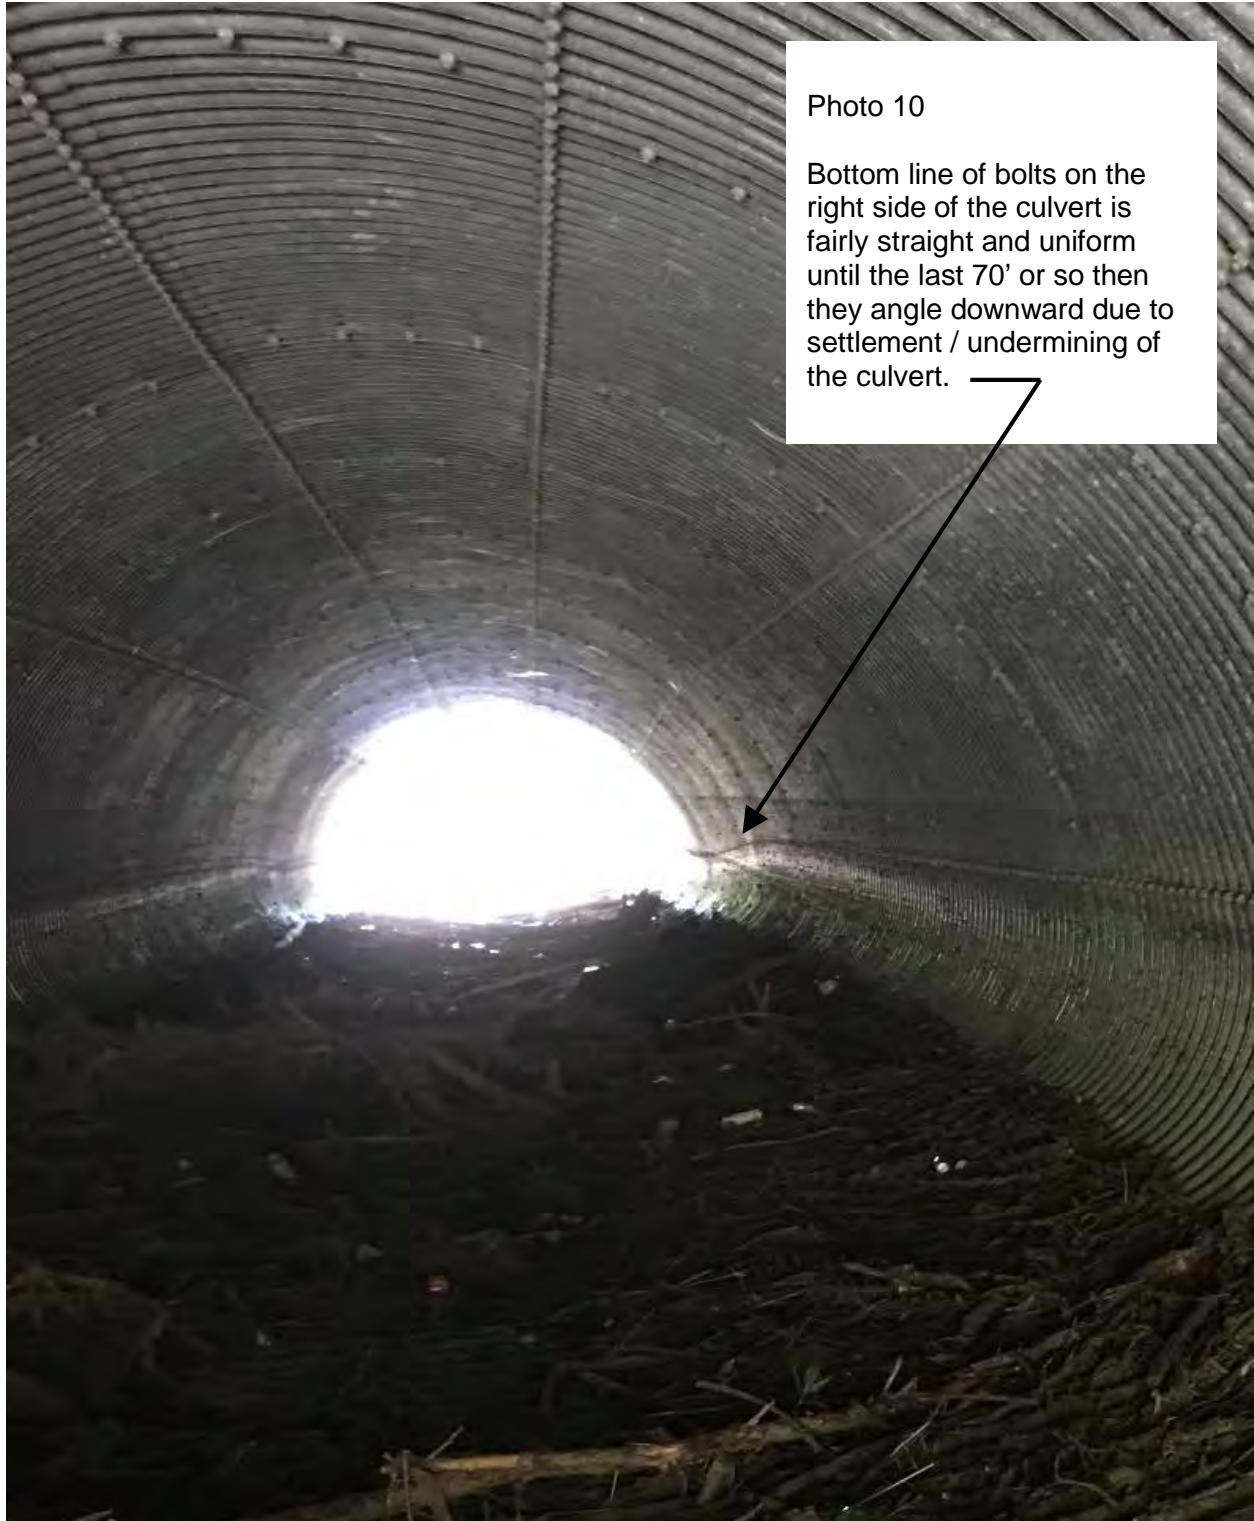
Photo 10

Roughly 70' or more of the downstream end of the culvert slopes / drops at a downward angle towards its outlet. The amount of drop was measured on 8-4-2017 to be 6" where the top of the culvert has separated from the concrete apron at its outlet. After the last major rainfall event the drop was measured on 8-7-2017 to be 8", an increase of 2". Refer to photos 9 and 10.

Photo 9 – downstream end of the north culvert showing 8" gap between the concrete apron and the top of the culvert.

Bottom line of bolts on the right side of the culvert is fairly straight and uniform until the last 70' or so then they angle downward due to settlement / undermining of the culvert.

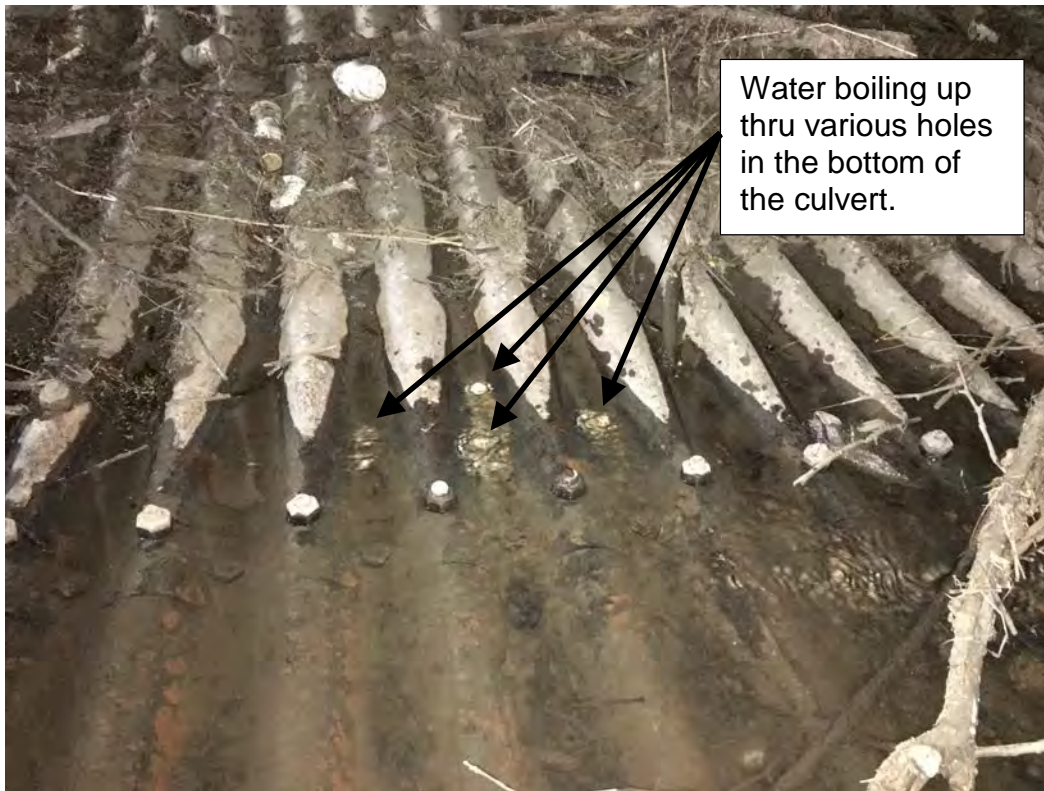
Photo 11

In the south culvert a fair percentage of the bottom corrugations have holes of various sizes in the trough of the corrugations beginning at a distance roughly 40' from the upstream end and extending to a point roughly 120' from the upstream end. At the 120' point water was seen boiling up through various holes in the bottom of culvert. Refer to photo 11 and Figure 1.

Probing indicated the depth of undermining and/or depth of soft material beneath the culvert to be 6" to 12" deep in this stretch. In addition, probing / sounding of the culvert indicated the last 72' of the downstream end was undermined as shown in Figure 1.

In our opinion the south culvert is approaching the end of its useful life due to undermining and its deterioration. At this time there is no apparent buckling or failure of the culvert but its condition should be monitored and checked after each significant rainfall event

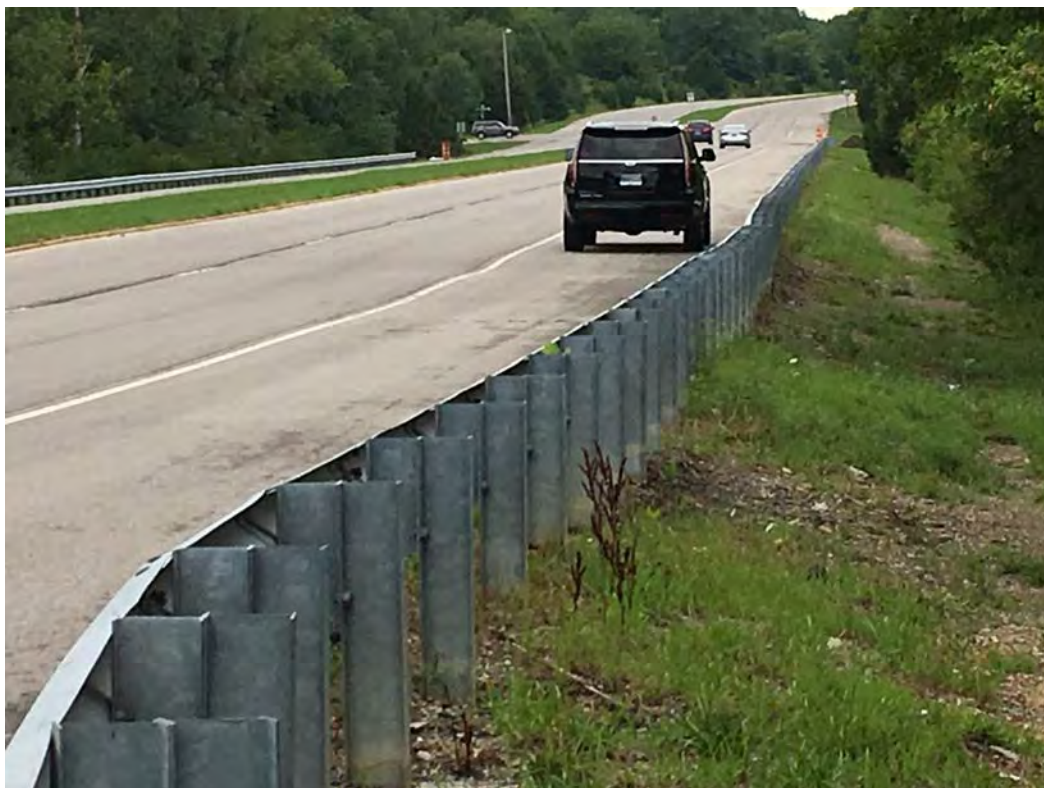
Above the north culvert there is a noticeable depression in the northbound shoulder of Raytown Road which extends out into the right northbound lane. This depression / settlement is also noticeable in the adjacent section of guardrail. There is no apparent distress in the asphalt surface at this time nor is it known if the depression is directly related to the condition of the culvert or loss of fill material beneath it. Refer to photo 12.

Photo 12 – depression in the northbound shoulder and right lane of Raytown Road.

At this time, it is recommended to monitor the depression for any noticeable changes and for any correlation with changes noted in either culvert.
