Summary

RAYTOWN ROAD
 CULVERT
 SHEET 1 OF 1

RAYTOWN ROAD
 4,000' NORTH OF HIGH GROVE
 ROADWAY STA. 52+00

CITY OF
GRANDVIEW
 1200 Main Street
 Grandview, MO 64030
 816-316-1800

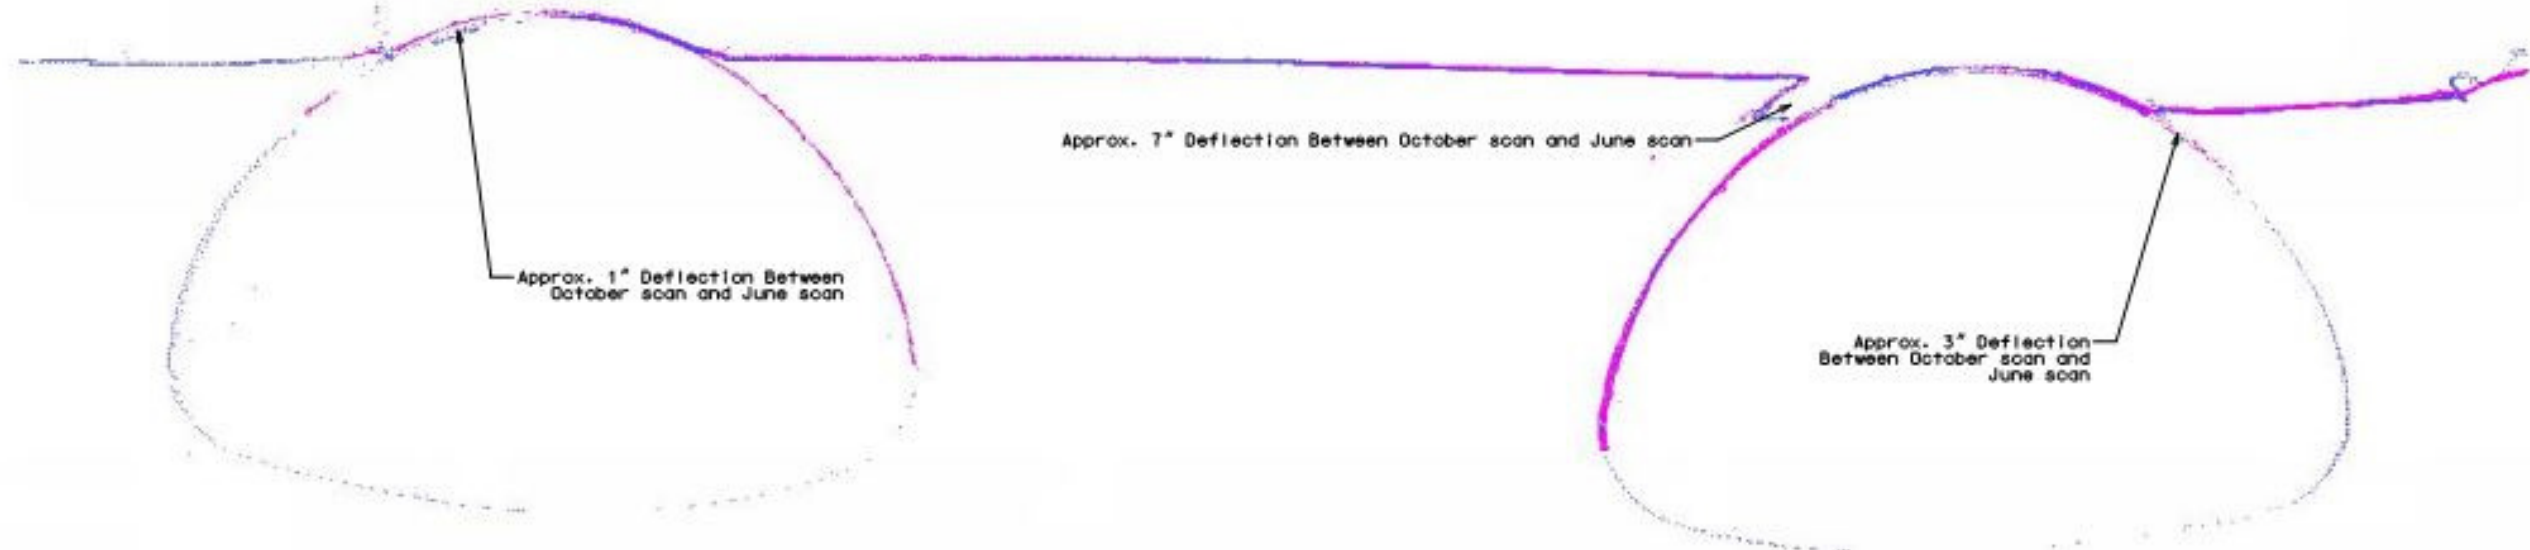
EAST SIDE OF RAYTOWN ROAD, LOOKING WEST

- South Culvert, East Side – The comparison of LIDAR scans indicates there is approximately 1" of deflection from the October 2017 to June 2018. This deflection was found at the top of the culvert which is moving down over time.

- North Culvert, East Side – The comparison of LIDAR scans indicates there is approximately 7" of deflection from October 2017 to June 2018. This deflection was found at the top of the culvert which is moving down over time.

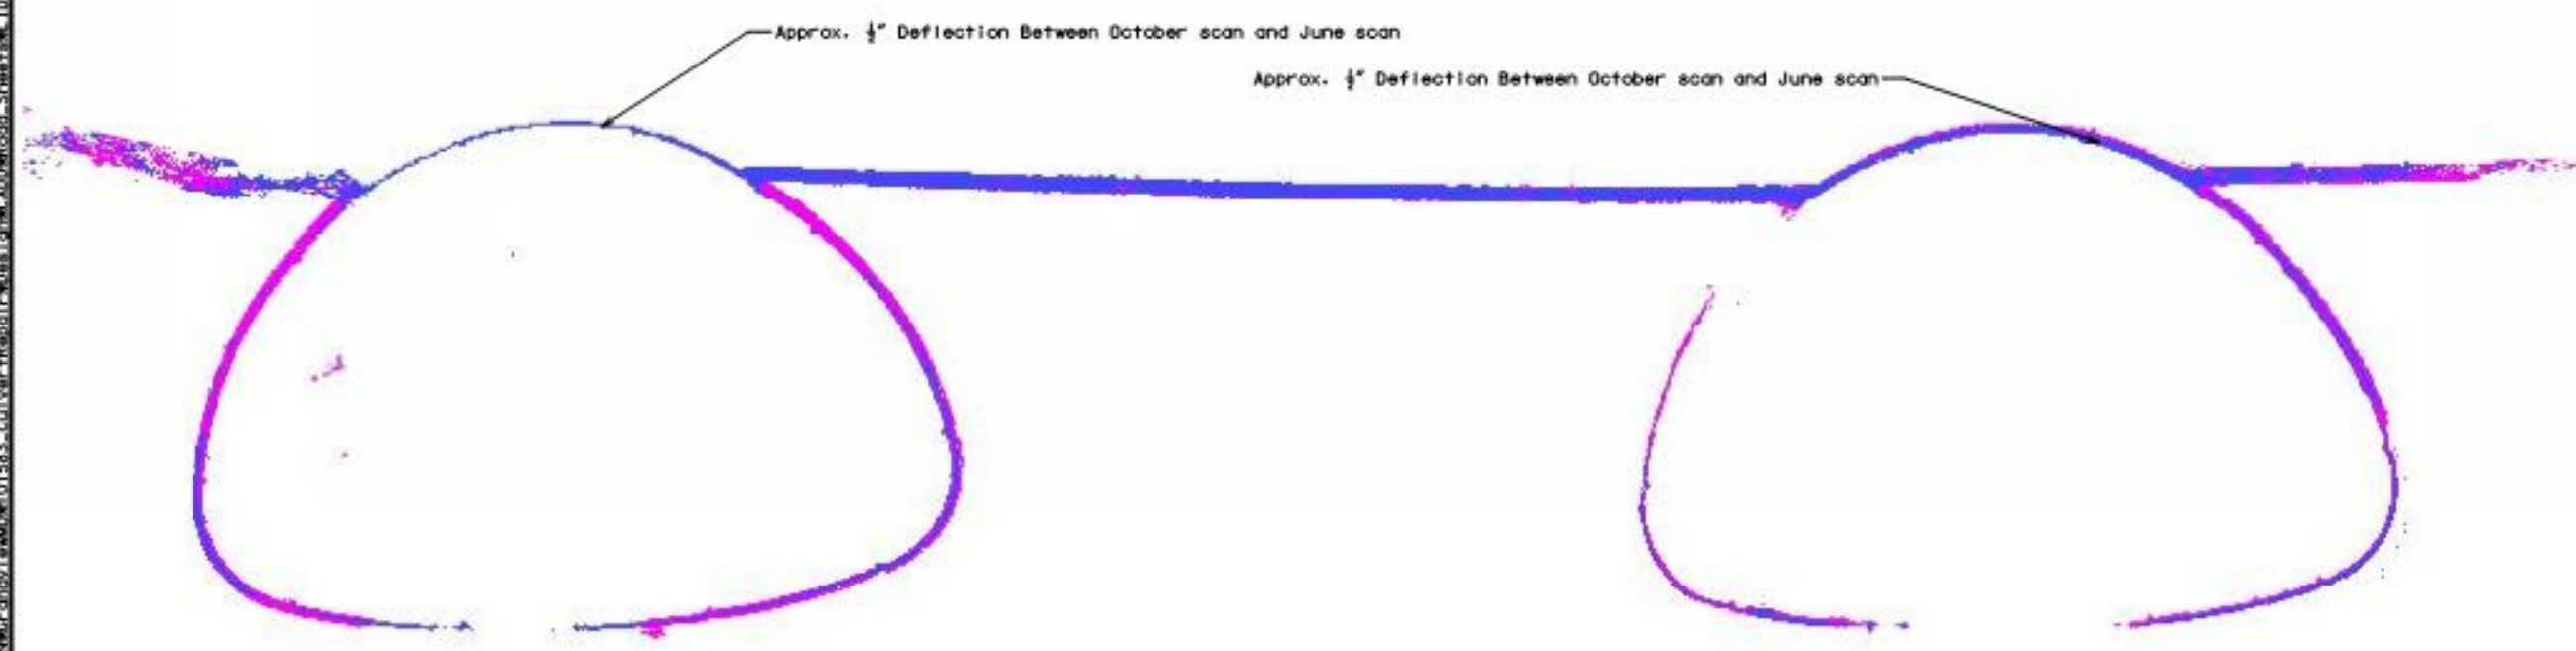
WEST SIDE OF RAYTOWN ROAD, LOOKING EAST

- North Culvert, West Side – The comparison of LIDAR scans indicates minimal deflection from October 2017 to June 2018. The data suggests a ½" deflection downwards at the top of the culvert but this is close to the tolerance of the LIDAR scan.

- South Culvert, West Side – The comparison of LIDAR scans indicates minimal deflection from October 2017 to June 2018. The data suggests a ½" deflection downwards at the top of the culvert but this is close to the tolerance of the LIDAR scan.
