## MEMORANDUM

**TO:** Jackie White, P.E., City Engineer, Grandview, MO  
**FROM:** David A. Church, P.E., PTOE, Senior Supervising Engineer, WSP USA, Inc.  
**SUBJECT:** Raytown Road Missouri STP Grant Application (2021-2022)  
**DATE:** March 21, 2018

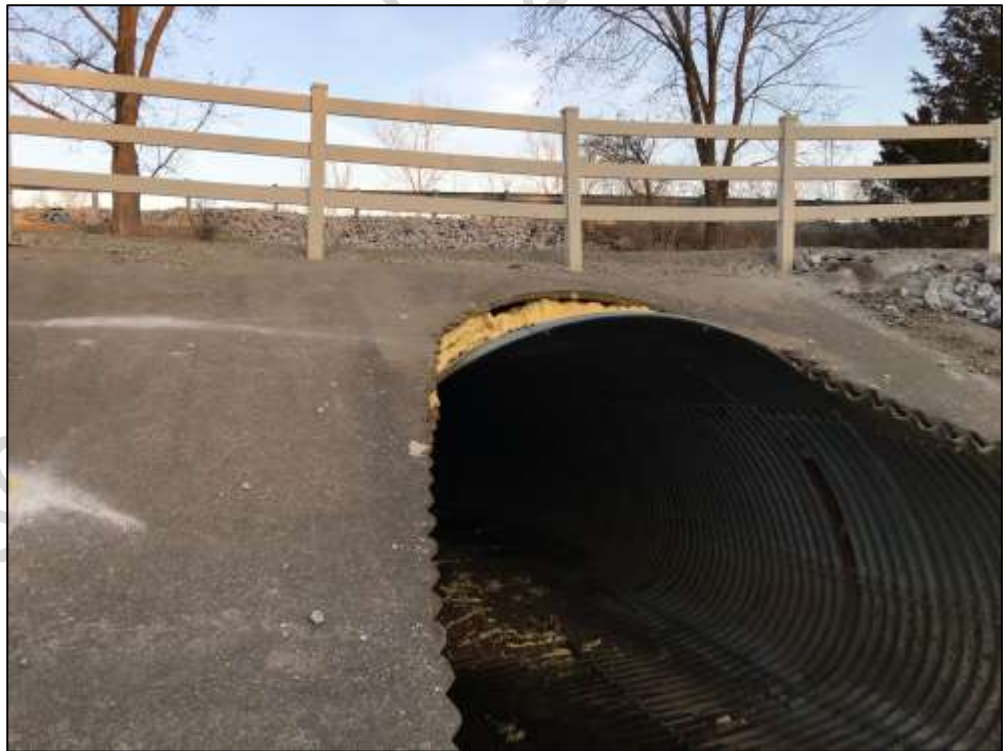
*Figure 1– Photograph of Existing CMP (1 of 2 CMPs) under Northbound Raytown Road  
Source: WSP, March 15, 2018*

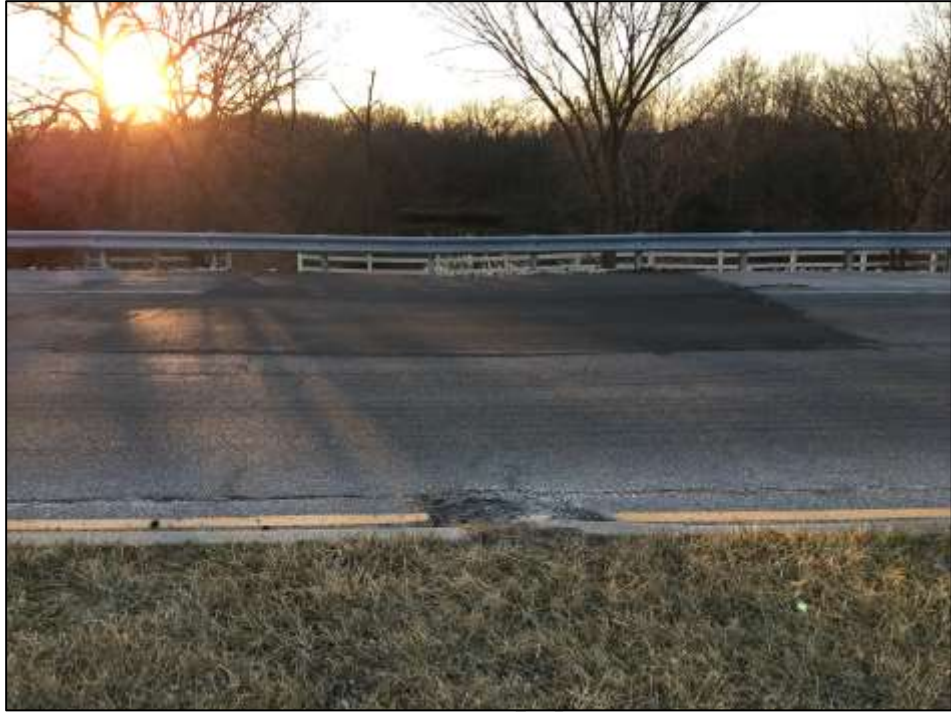
It is possible that if no long-term solutions are utilized to address the existing CMPs, that the pavement along the outside lane of the northbound approach will continue to sag as the CMP beneath it transforms, as seen in the photo taken on March 15, 2018 (Figure 2). Raytown Road is also an official bicycle route with signing and markings on the shoulder (Figure 3). Safety related consequences involved in continuous monitoring and maintenance of the existing CMPs effect on the Raytown Road pavement include:

- “Sag” in the northbound Raytown Road outside through lane and shoulder (cyclists)
- Potential location for ponding water during rain events
- Exposure to traffic for City Maintenance personnel while maintaining pavement patch
- Continuous monitoring of future pavement and fill slope movement (Figure 4)

*Figure 2 – Photograph of Northbound Raytown Road Pavement Sagging on Top of Existing CMP  
Source: WSP (March 15, 2018)*

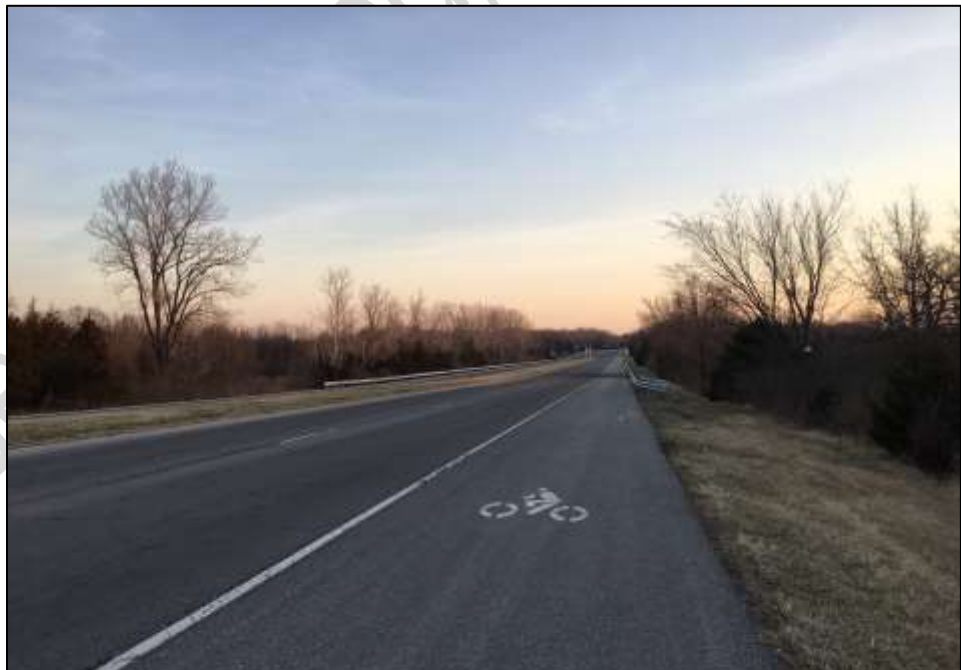
*Figure 3 – Photograph of Northbound Raytown Road Approaching Project Site with Bicycle Symbol on Shoulder  
Source: WSP (March 15, 2018)*

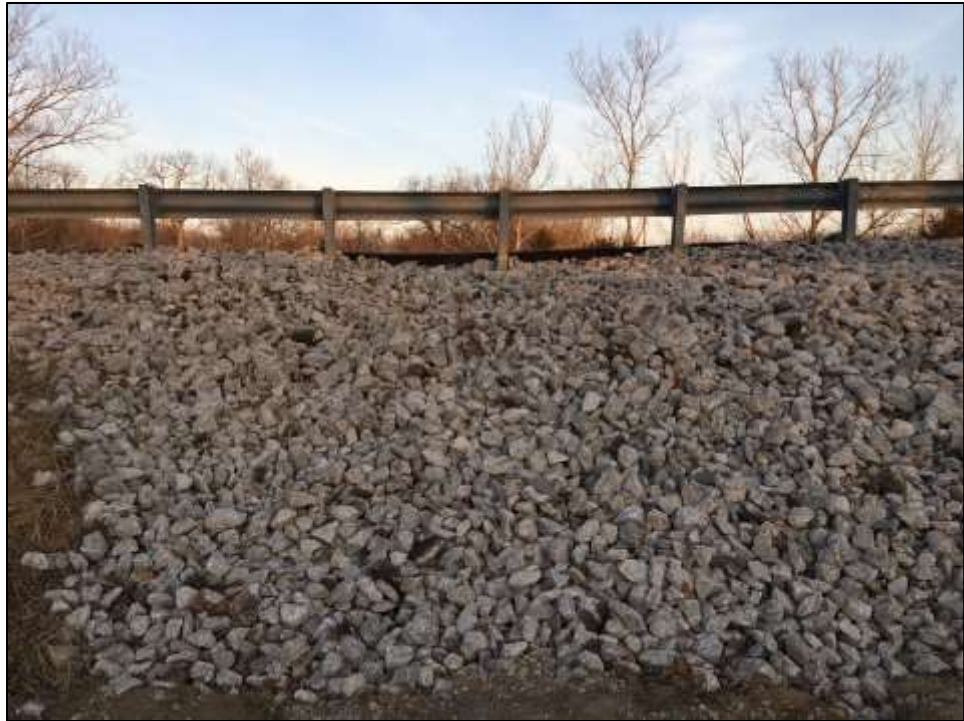
*Figure 4 – Photograph of Northbound Raytown Road Fill Slope Protection  
Source: WSP (March 15, 2018)*
